TRANSPORTATION RESEARCH CENTER

ON-SITE AIR BAG INVESTIGATION

CASE NO. - 96-15
FLEET - PRIVATE VEHICLE
LOCATION -
ACCIDENT DATE - 1996

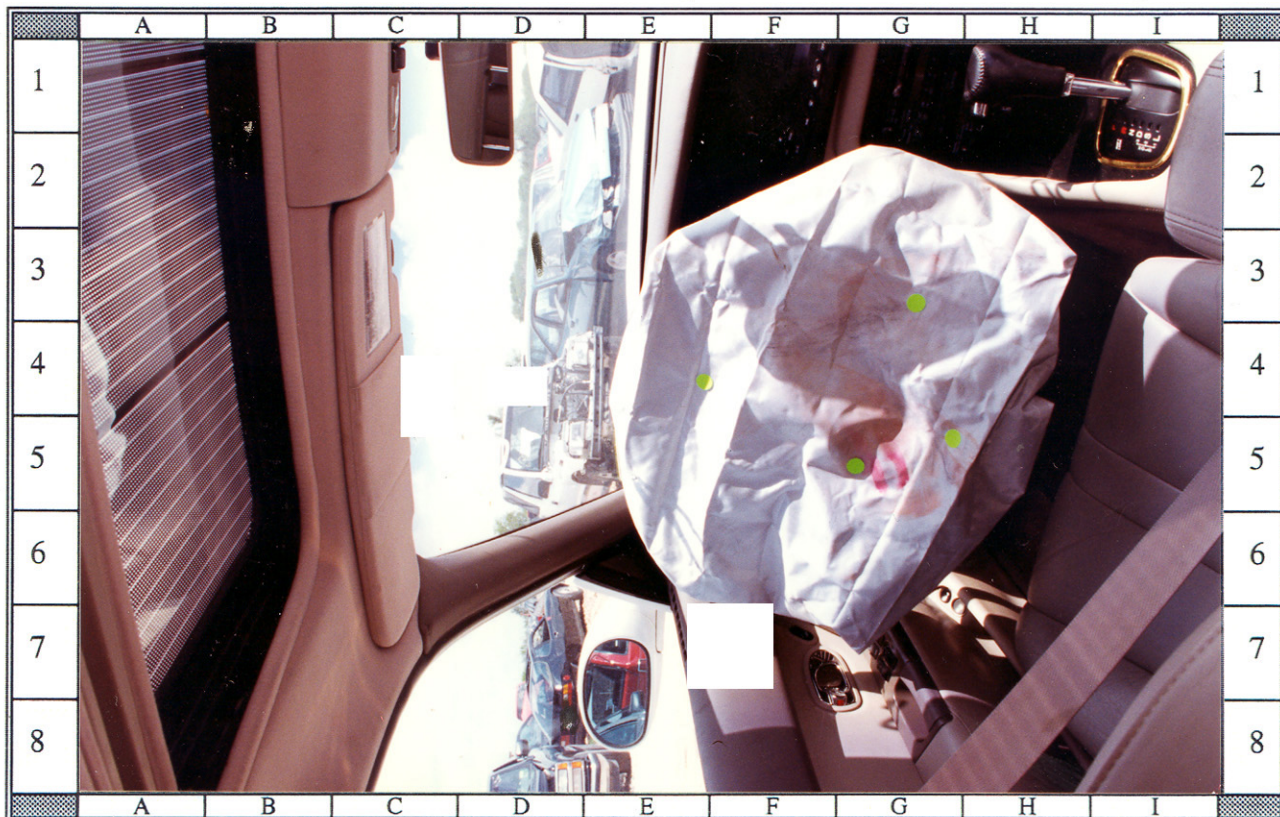
22: Vertical view of Case Vehicle's driver seating area, greenhouse, and deployed air bag; NOTE: lipstick and makeup transfers to driver's air bag

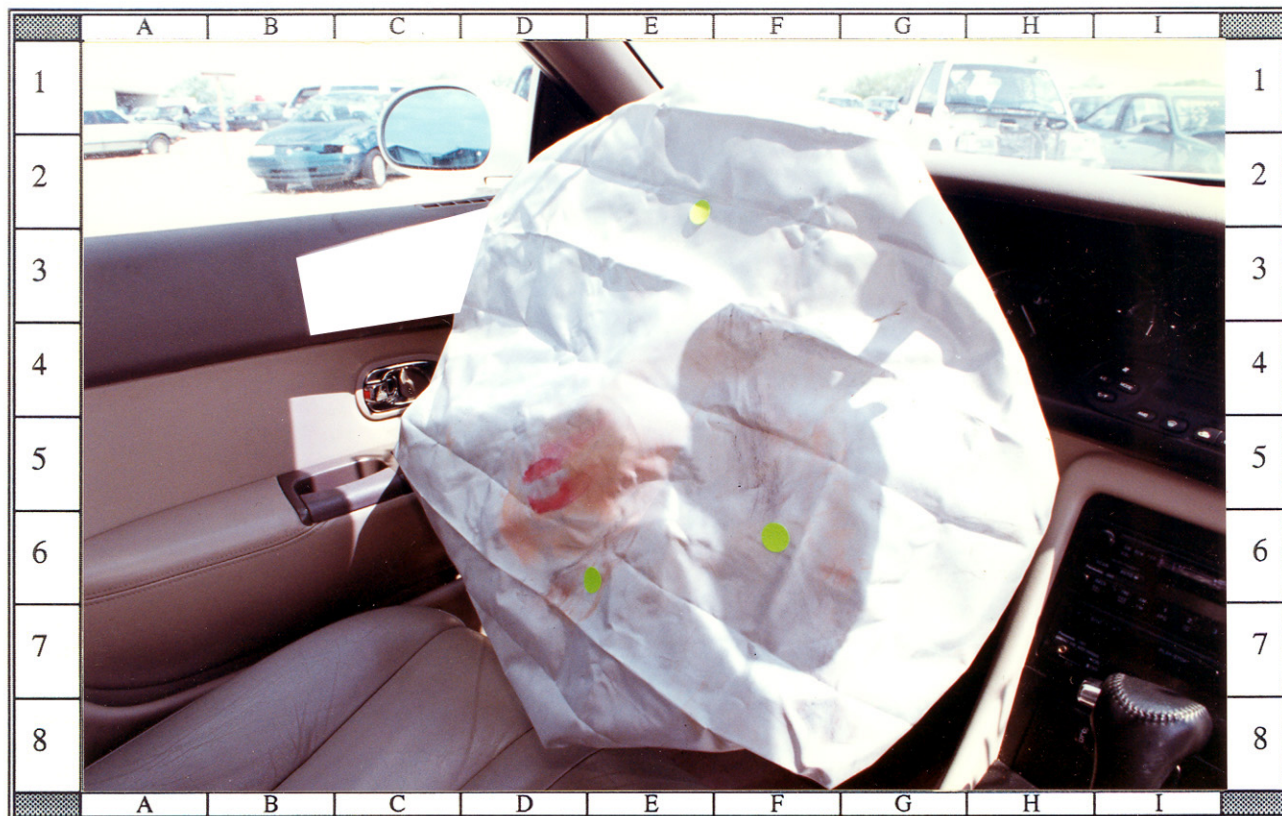
23: Closer-up view from rear center of contact evidence to Case Vehicle's driver air bag showing distinct lipstick imprint

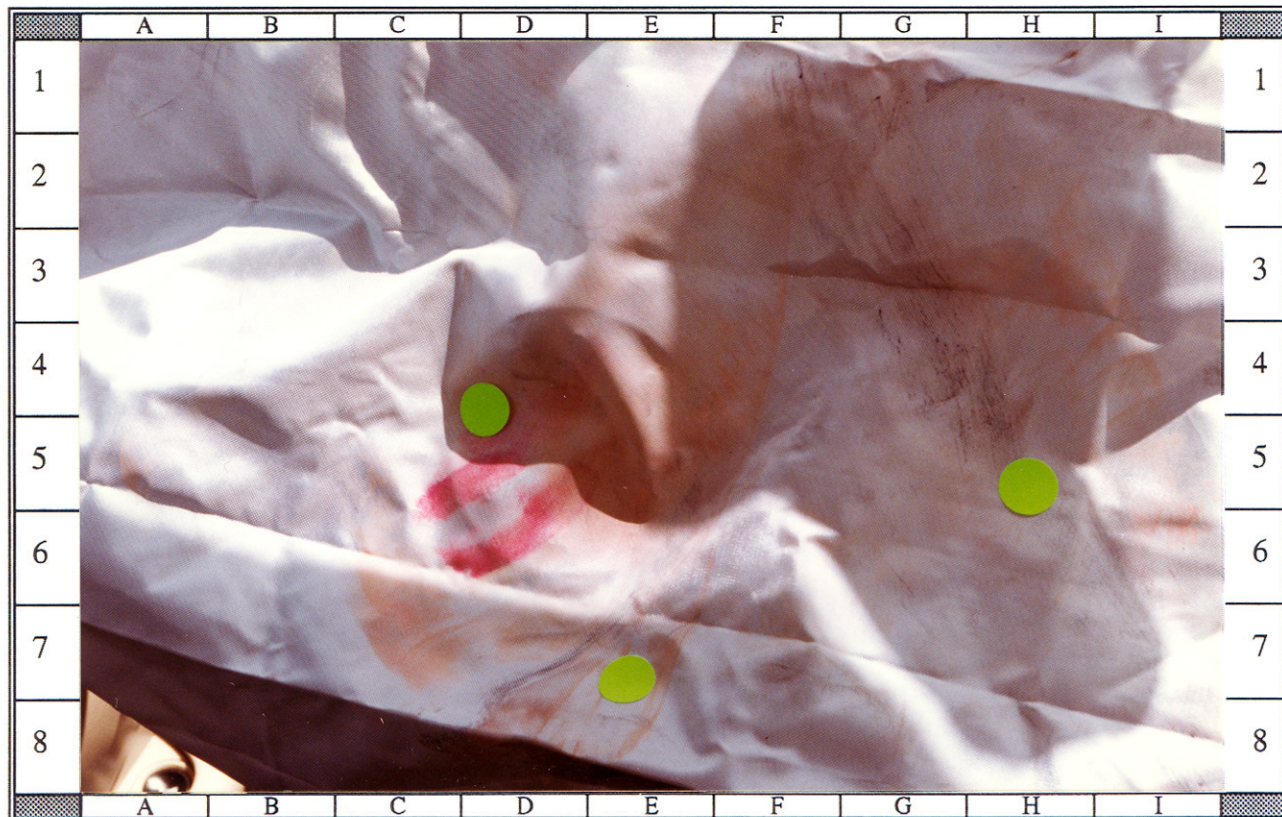
24: Closest-up view of contact evidence to Case Vehicle's driver air bag; NOTE: lipstick, eye, and face make-up transfers

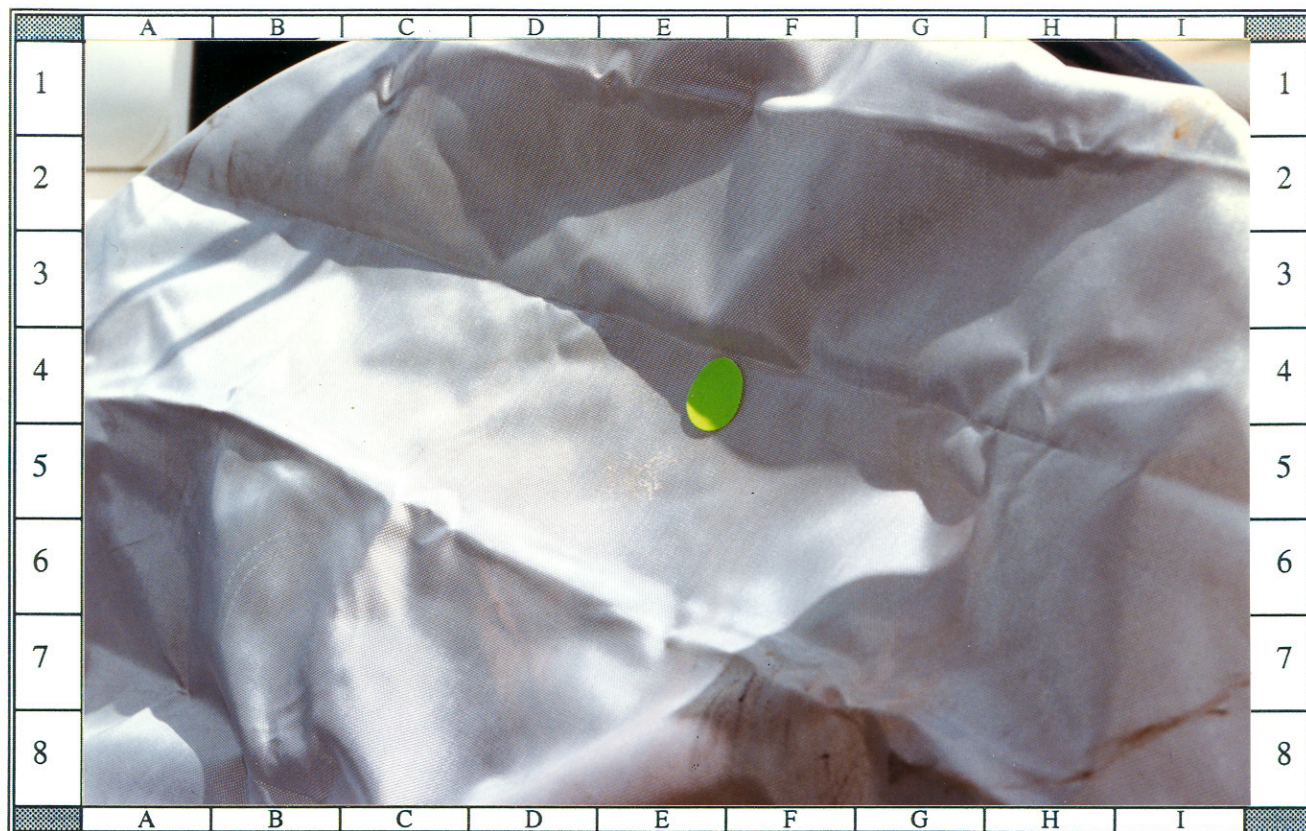
25: Close-up view of mucous transfer (below green dot--cell E5) to upper portion of Case Vehicle's driver air bag

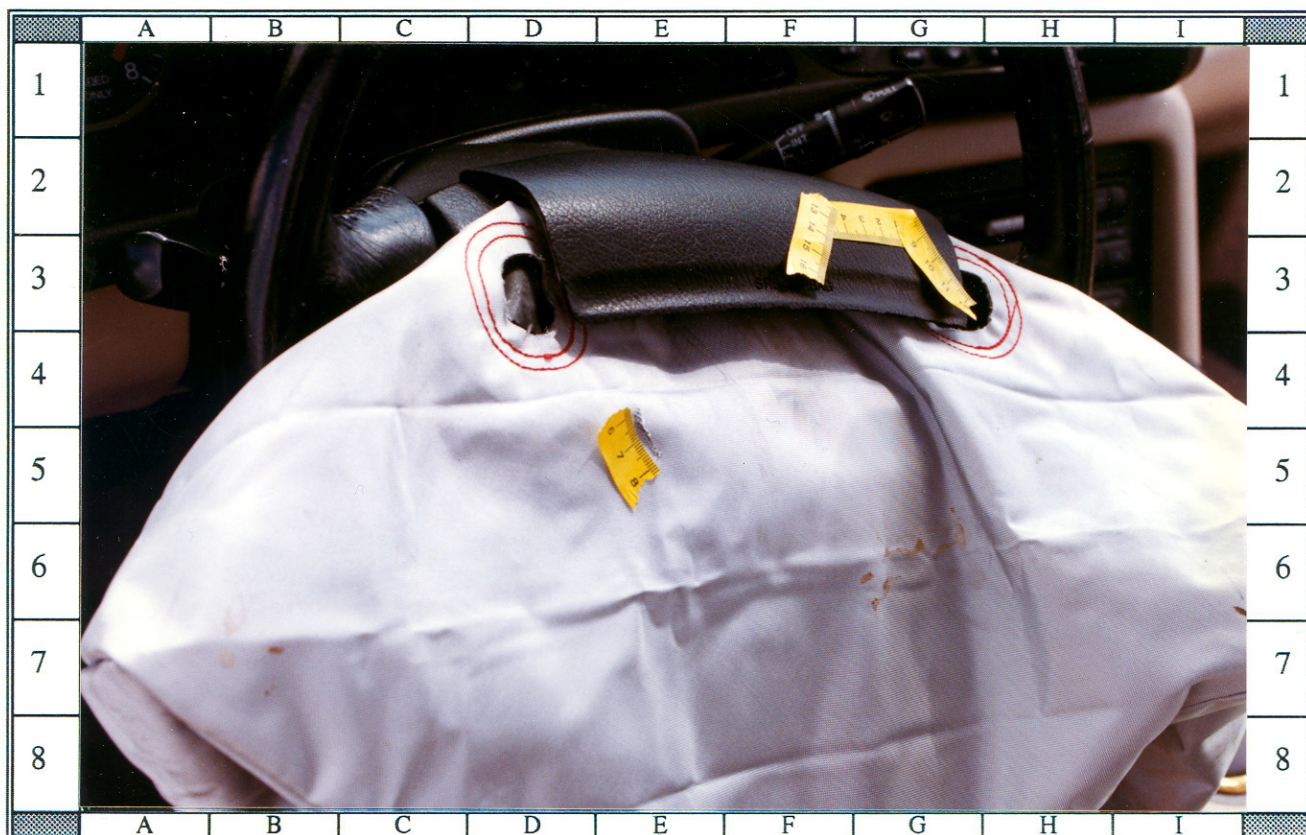
26: Close-up view of slight tear (cells E4--E5) found on backside of Case vehicle's deployed driver air bag; NOTE: mark on cover flap (cell G3)

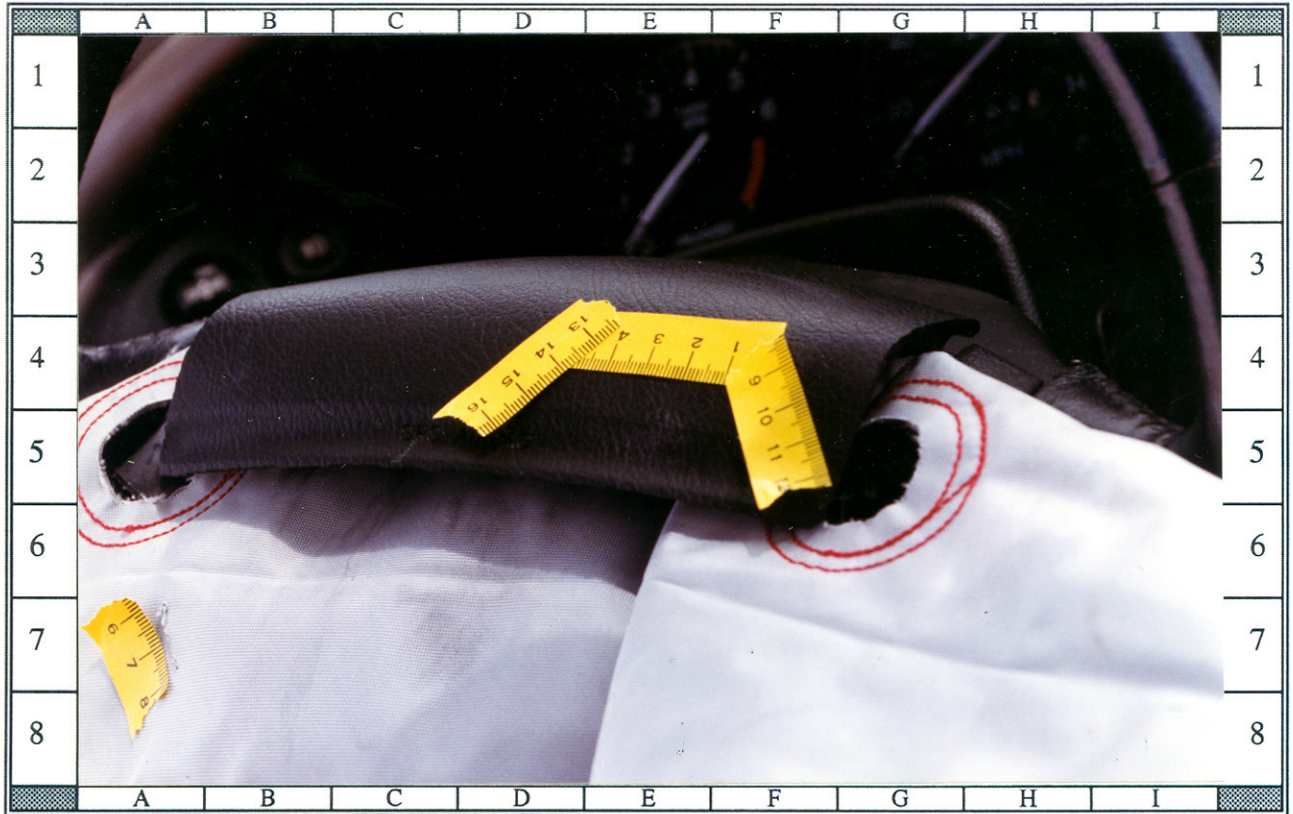
27: Close-up of unknown mark on Case Vehicle's driver side air bag module's top cover flap; NOTE: mark is most likely not from occupant contact

The case vehicle departed the left side of the roadway striking the bridge rail. According to the case vehicle's driver, the initial and primary impact with the left bridge rail did not deploy¹³ the case vehicle's air bags, but instead the secondary/minor impact with the right bridge rail caused them to deploy. Based on the vehicle inspection (*see further discussion below*) and occupant kinematic principles, the case vehicle's primary impact with left bridge rail, not only deployed the driver's air bag, but thrust the driver forward and slight leftward loading her three-point lap and shoulder belt. The driver's safety belts most likely kept the driver in a relatively good driving position. An inspection of the driver's air bag revealed a distinct lipstick deposit and what appears to be facial makeup moving up and toward the right side of the air bag; see **SELECTED PHOTOGRAPHS #22 through #24**. In addition, there does not appear to be occupant interaction evidence on the driver air bag module's cover flaps; see **SELECTED PHOTOGRAPH #27**.

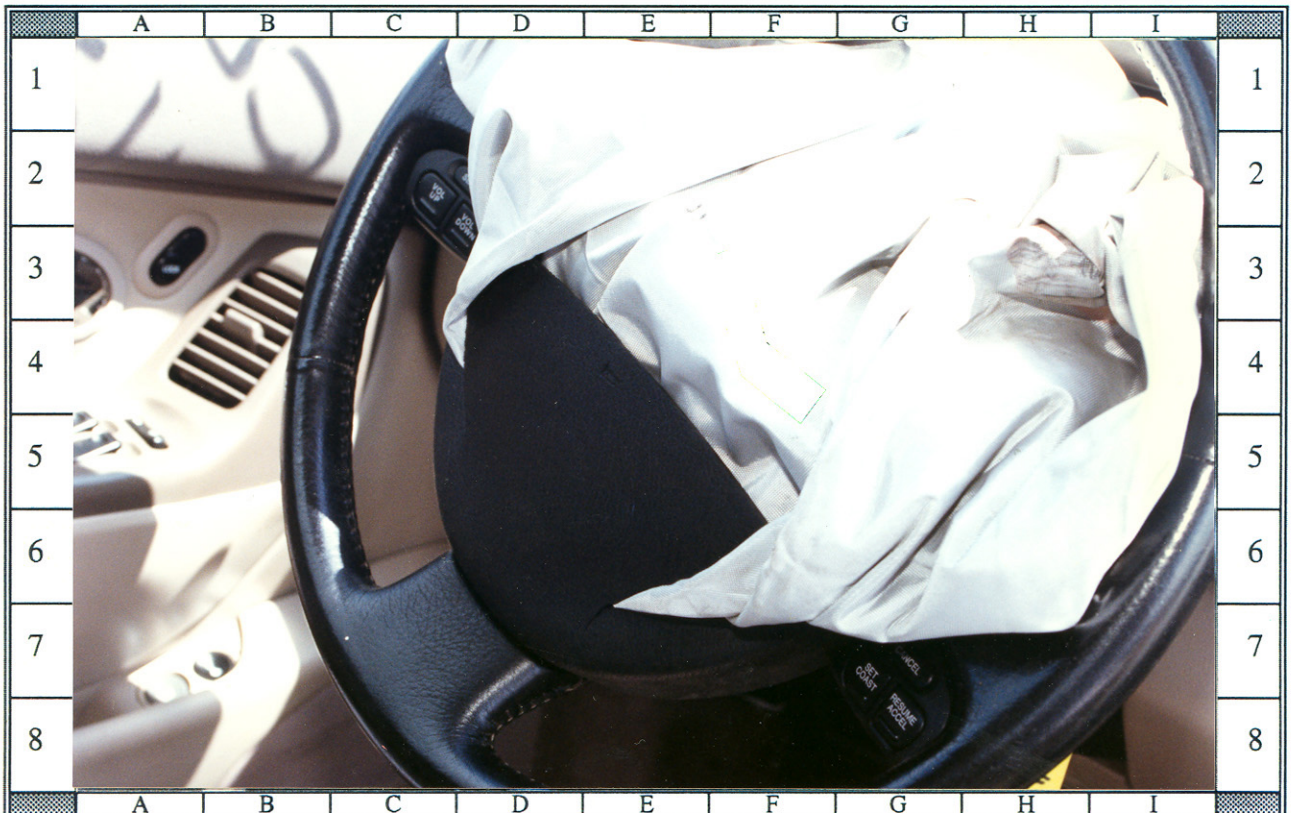
28: Close-up of Case Vehicle's driver side air bag module's bottom cover flap and steering wheel rim; NOTE: no evidence of contact or deformation

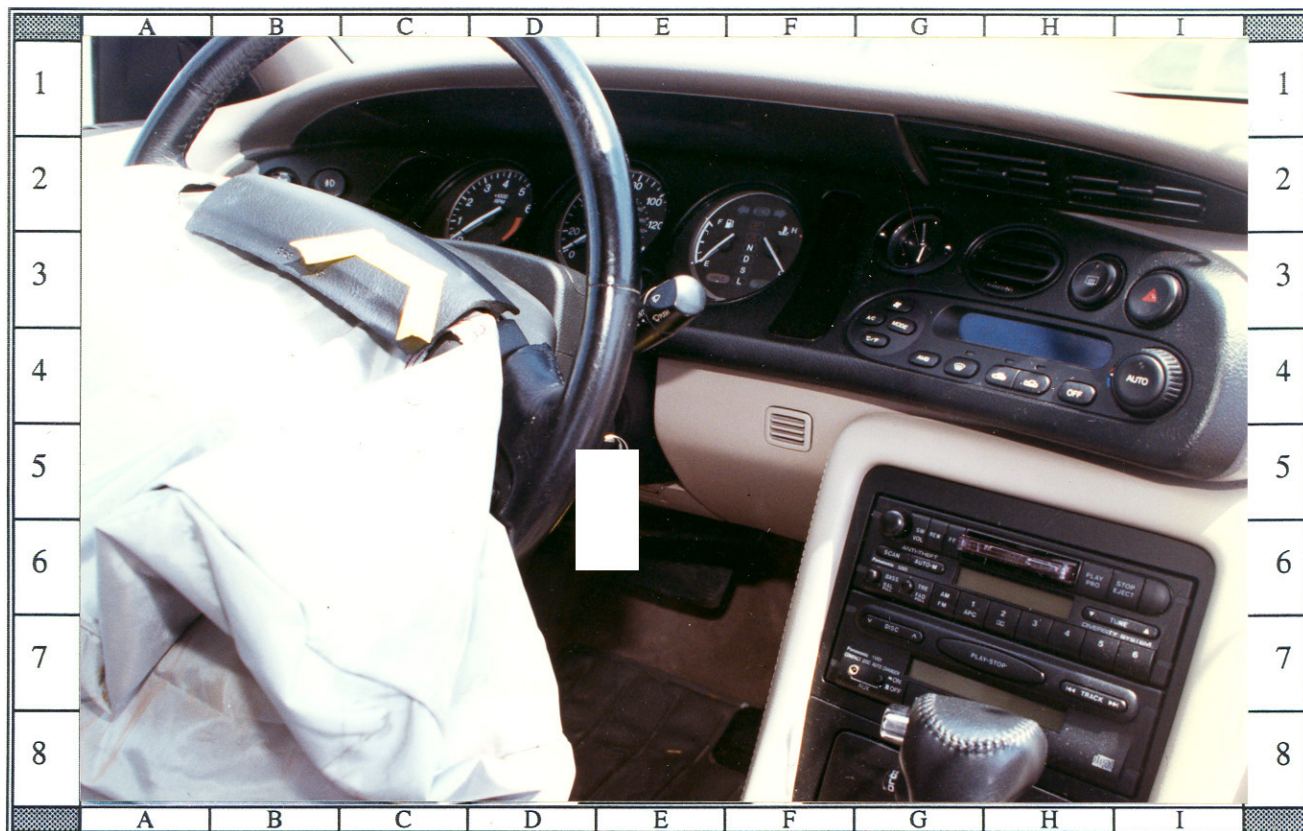
29: Right side of Case Vehicle's driver knee bolster and center instrument panel showing no evidence of contact

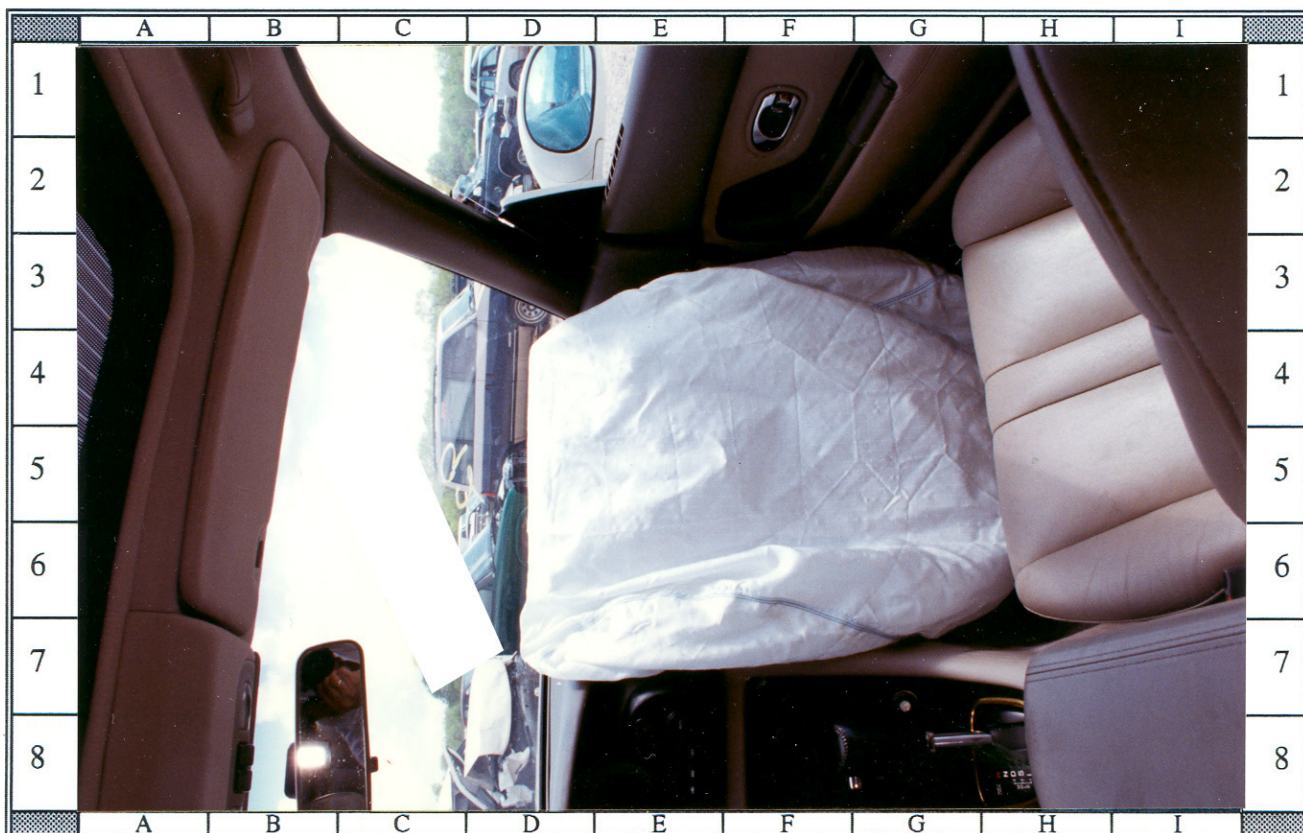
30: Vertical view of Case Vehicle's deployed right front passenger air bag, front dash, windshield, and rearview mirror viewed from center rear seat

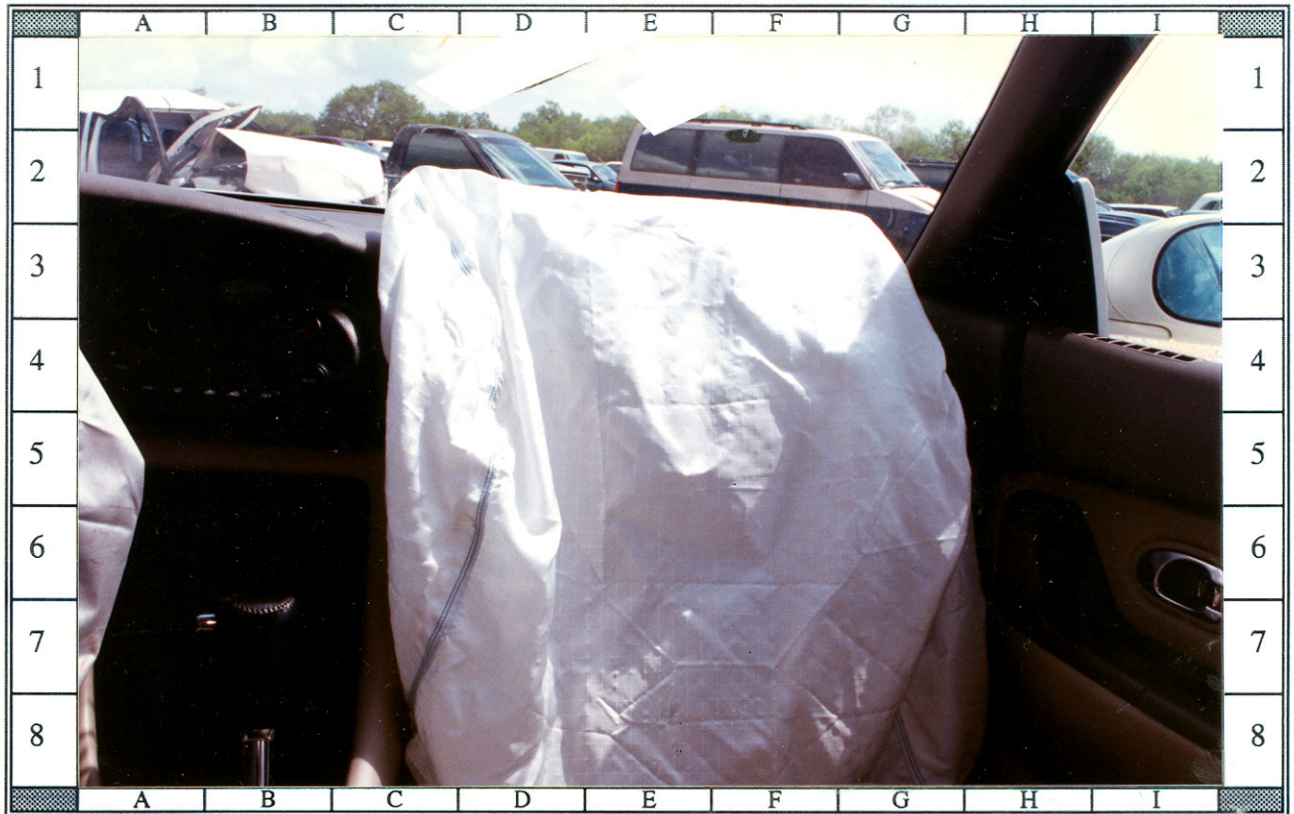
31: Closer-up view from rear center of Case Vehicle's deployed, noncontacted, right front passenger air bag; NOTE: driver only occupant in vehicle

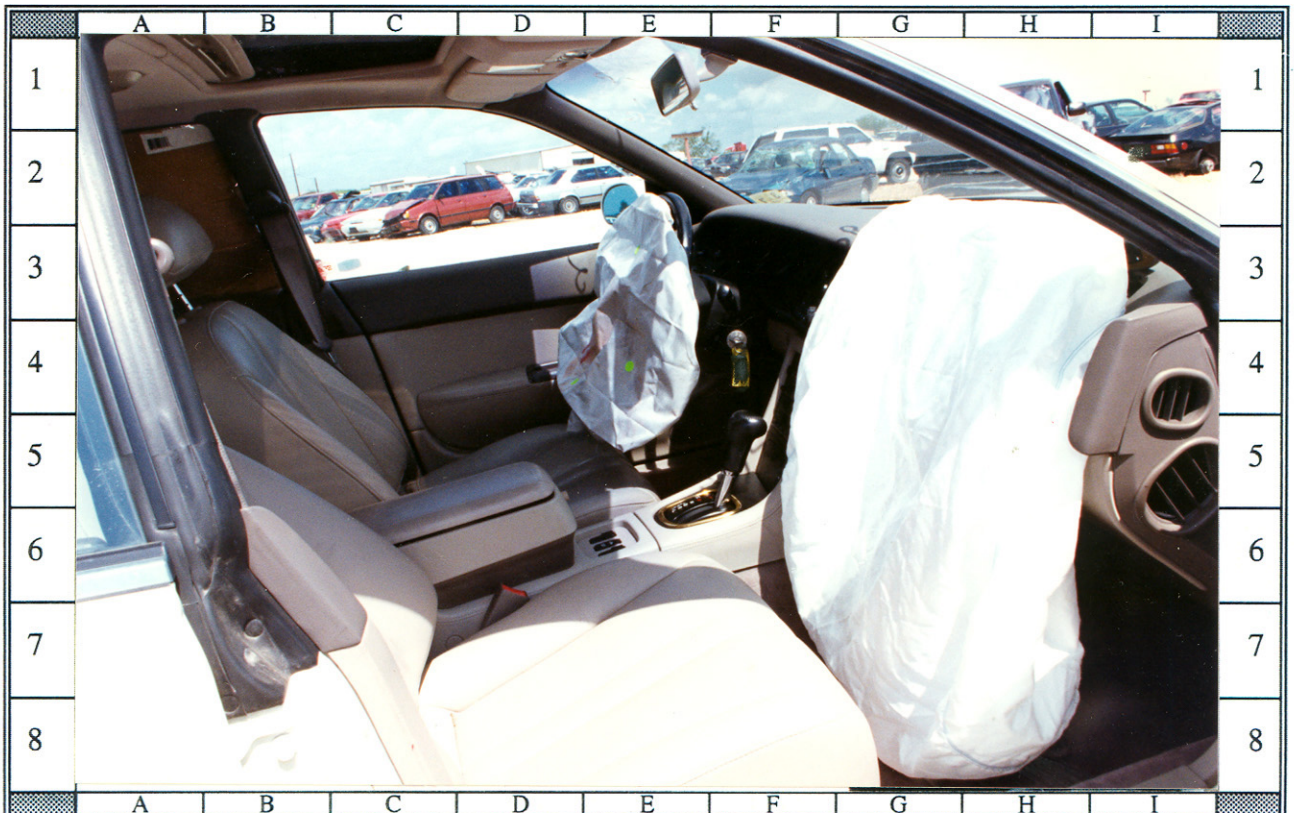
32: Case Vehicle's front seating area, greenhouse, and deployed air bags viewed from outside right front passenger door

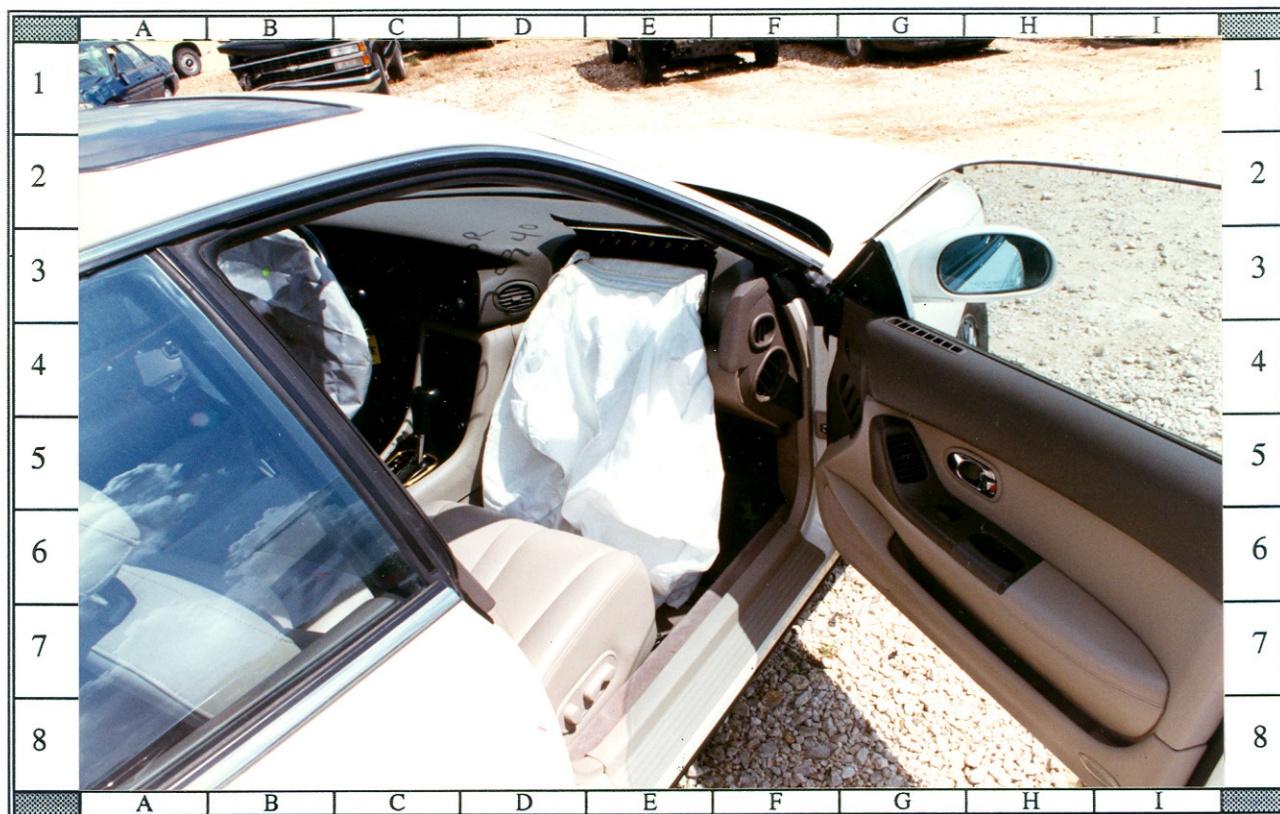
33: Interior surface of Case Vehicle's right front passenger door, seating area, and deployed air bag; NOTE: no right front occupant or contact evidence

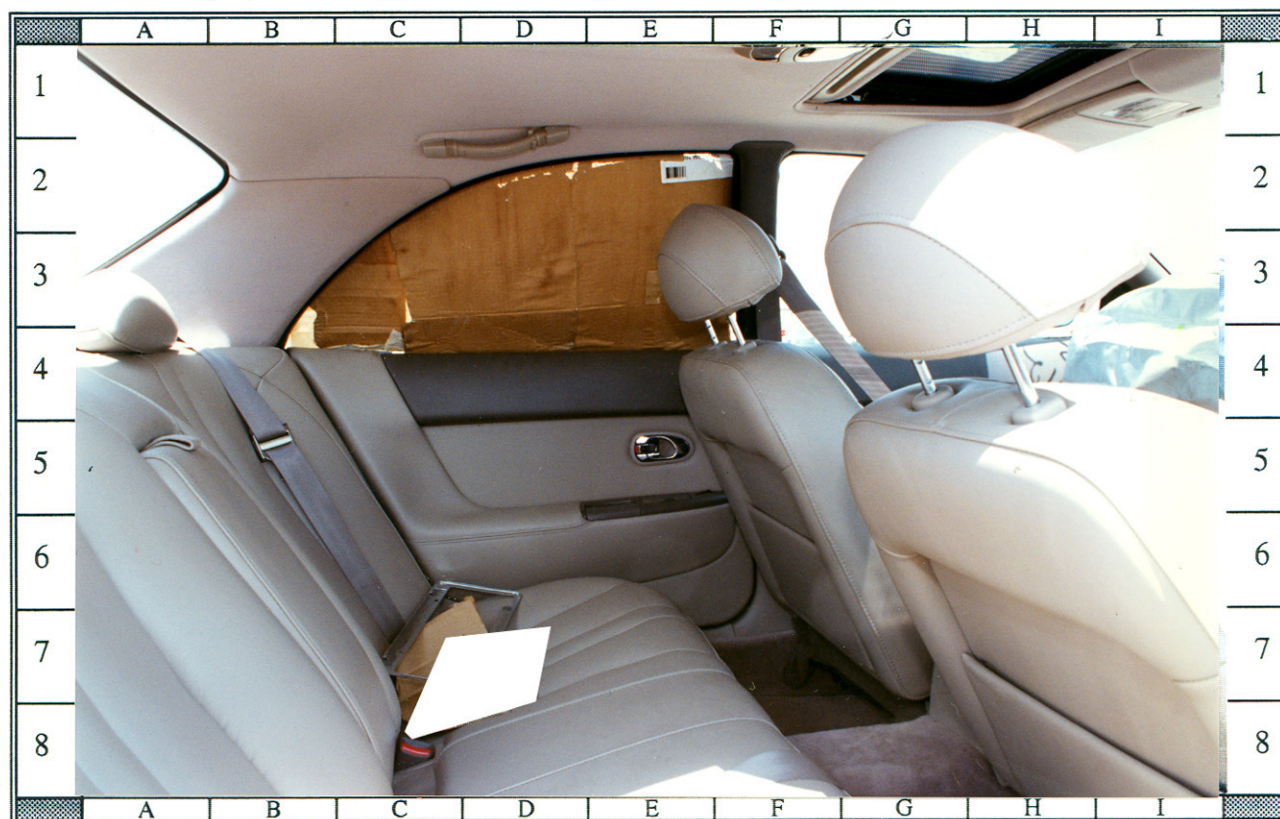
34: Case Vehicle's rear seating area; NOTE: front and rear headrests, outboard three-point belts, and blown-out left rear window
